HIGHLY LOADED COMPOSITE STRUT TEST RESULTS

K. CHAUNCEY WU and DAWN C. JEGLEY

NASA Langley Research Center, Mail Stop 190, Hampton VA 23681

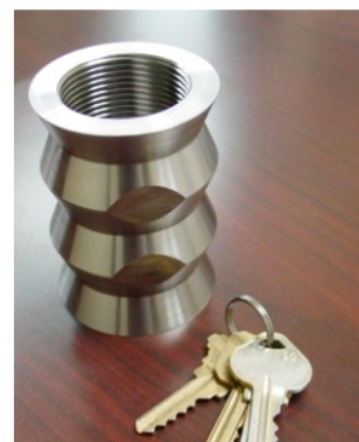
Fig. 3. Titanium end fitting.

The struts tested consisted of a carbon fiber/epoxy body fabricated using pre-impregnated (prepreg) IM7/8552 tow and tape materials. The uniform-diameter tubular composite body in the center of the strut tapered down to a smaller diameter at both ends. Titanium end fittings, shown in Fig. 3 prior to fabrication of the strut, were built into the strut ends for load introduction and to interface with the test hardware. This end fitting has several facing truncated conical ramps that are overlaid and overwrapped with the composite strut material during fabrication. The internal threads of the end fitting engage a test fitting attached to the test facility.

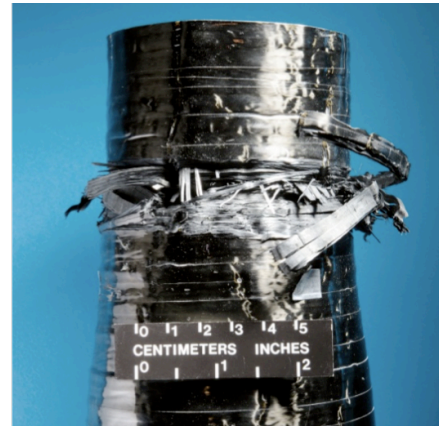
Fig. 12. Failed strut end fitting.

In Fig. 12, the upper end of the failed NG-2 strut shows many circumferential tows overwrapped on the titanium end fitting that were destroyed when the strut failed, but no external damage was observed on the lower end of this strut. There were no non-destructive evaluations performed after testing to quantify internal damage.
